# Fire in Locomotive NR8

Cardiff, New South Wales, 4 April 2016

**ATSB Transport Safety Report**  
Rail Occurrence Investigation  
RO-2016-003  
Final – 18 January 2018

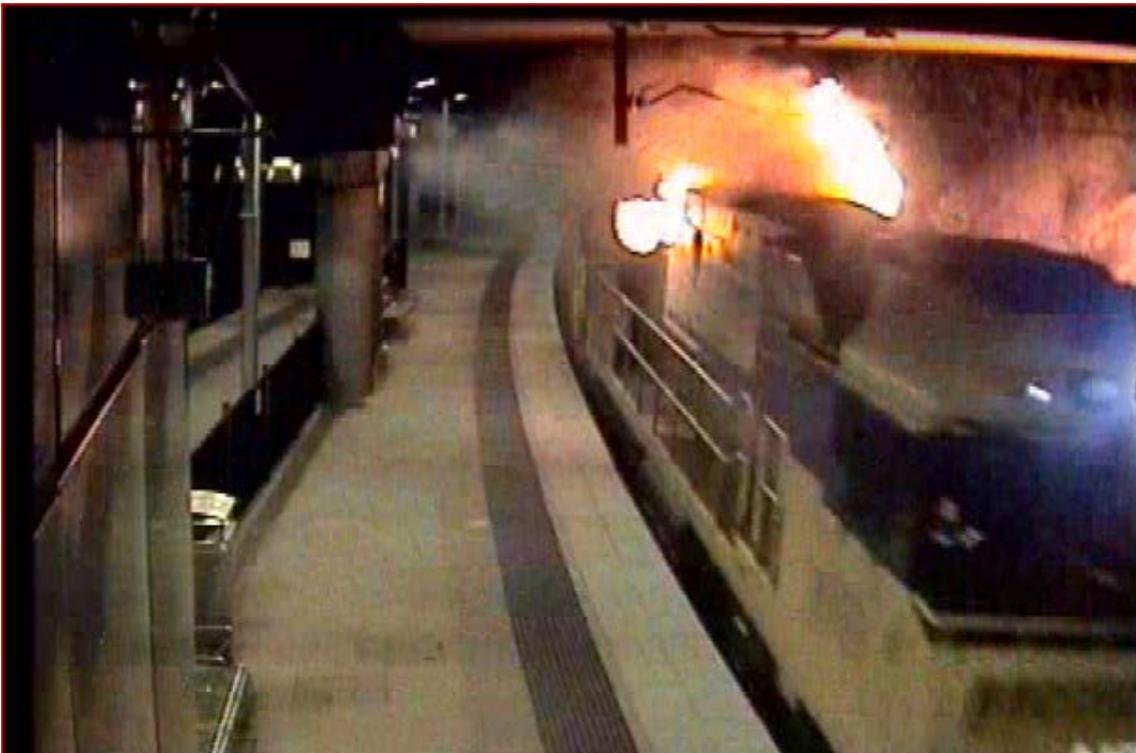
**Figure 1: Fire in lead locomotive NR8 passing through Cardiff Station**

On 4 April 2016 at approximately 0505 Australian Eastern Time (EST),<sup>1</sup> lead locomotive NR8 on train 7YN2 caught fire near the southern side of Cardiff railway station, New South Wales (NSW). The crew stopped the train 250 metres north of Cardiff station after they were alerted to the fire by flames emanating from the locomotive's engine cab. The crew informed Network Control<sup>2</sup> they could not contain the fire and requested the assistance from NSW Fire and Rescue (NSWFR). At 0510, the crew applied the locomotive park brake and both crew members evacuated without injury. The crew further secured the train by applying the hand brakes on the first 10 wagons and isolated the other two locomotives. NSWFR attended at 0525 but could not commence extinguishing the fire due to the overhead electrical wiring remaining energised. At 0535 an engine explosion displaced a number of engine crank case inspection covers. At 0543 passenger service N116 was stopped from passing the burning locomotive and passengers were detrained to alternative transport. At 0635 the overhead wiring was de-energised and by 0830 NSWFR had extinguished the fire.

The ATSB found that two of the 10 oil filter tank cover bolts had failed beneath the retaining nut due to fatigue and overload fractures. There was evidence of fretting damage on the tank cover at the failed bolt positions. This was consistent with a loose bolted joint associated with in service movement of the assembly. The fire ignited when the displaced tank cover enabled high pressure oil to escape and come in contact with hot engine components (Figure 1).

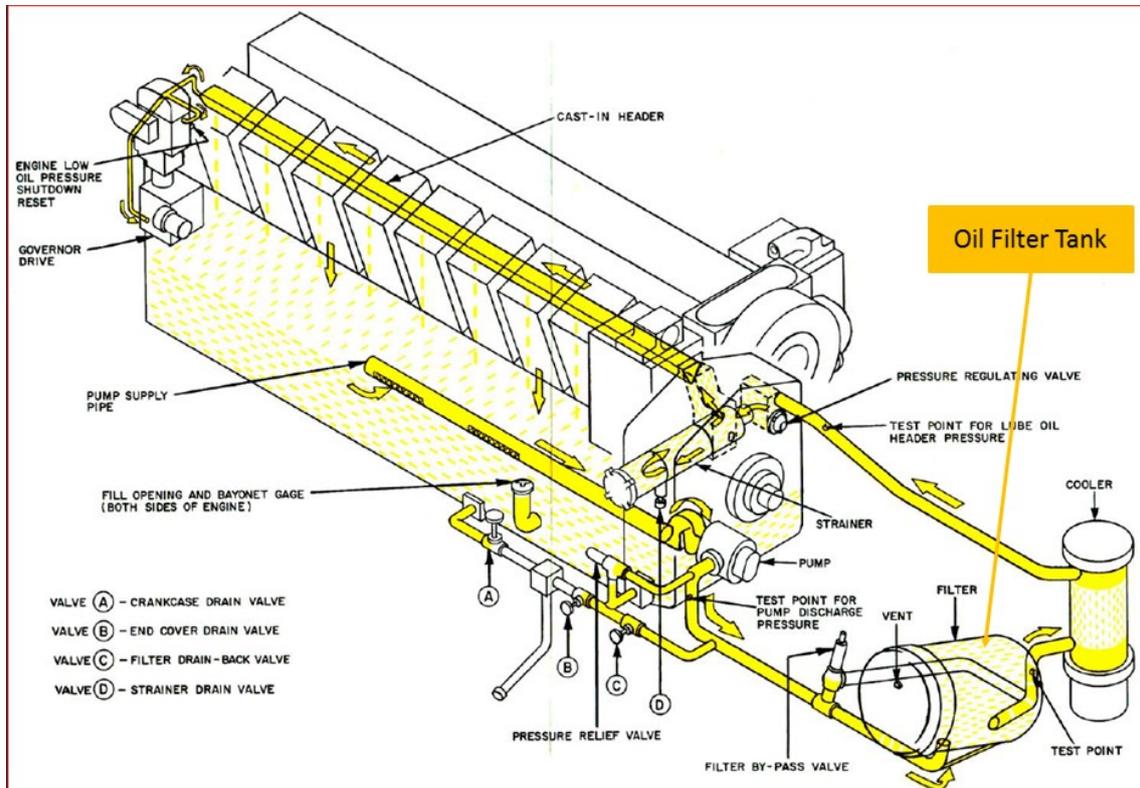
**Figure 2: Schematic of engine oil lubricating system**

The oil filter tank is a part of the locomotive engine's lubricating oil system (Figure 2 and 3). The lubricating oil system capacity is approximately 1500 l. There was approximately 800 l of lubricating oil left in the system after the incident.

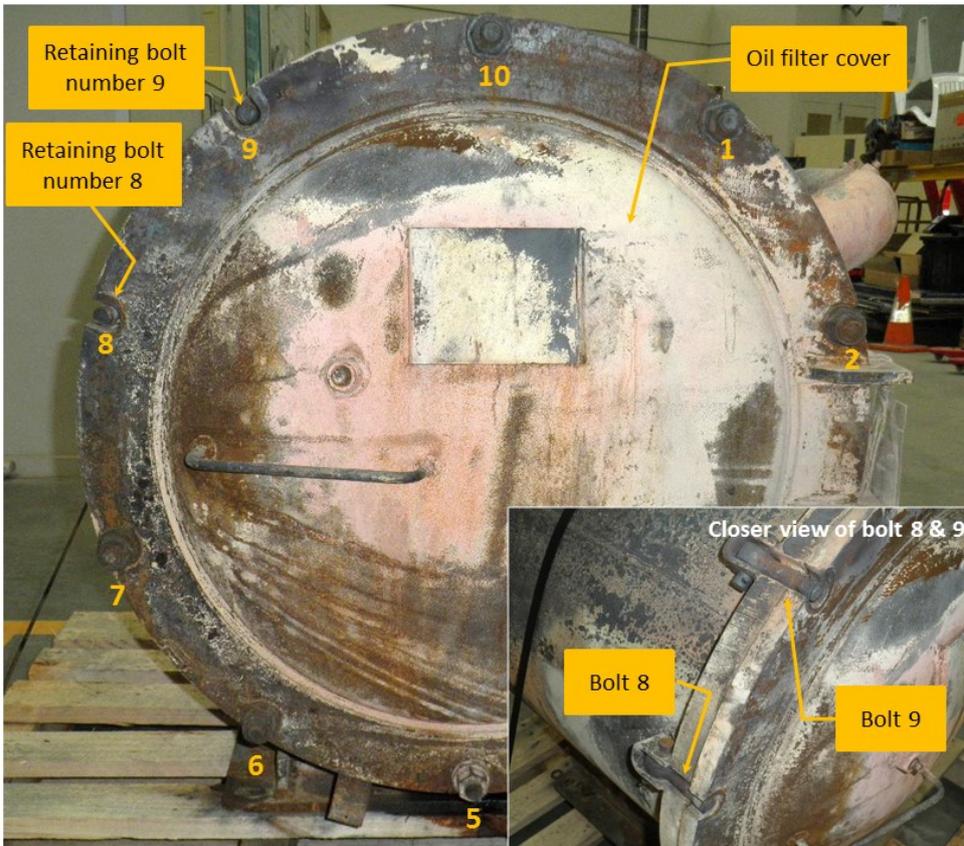
**Figure 4: NR8 oil filter tank and cover**

An independent metallurgist established that the 19 mm diameter oil filter cover bolts (Figure 4) had suffered unidirectional fatigue failure through the root diameter of the thread. The fractures occurred directly below the nut adjacent to the cover's nut seat. The nut seat exhibited fretting damage, which suggested there was movement across the bolted joint and most likely attributed to excessive torquing of the bolts.

The fracture surfaces of the broken bolts suggested the bolts had been moving transversely to the plane of the cover causing micro fractures at the root of the thread adjacent to the nut seat. Each movement of the bolt would have increased the size of the fatigue fractures and progressively reduce the bolt's tensile strength.

- Developed and implemented a bolt tightening and removal procedure
- Reduced the bolt replacement frequency from 732 days to 366 days
- Retrofitted a guard in NR locomotives to minimise the risk of oil escaping from the filter tank and contacting hot engine components.

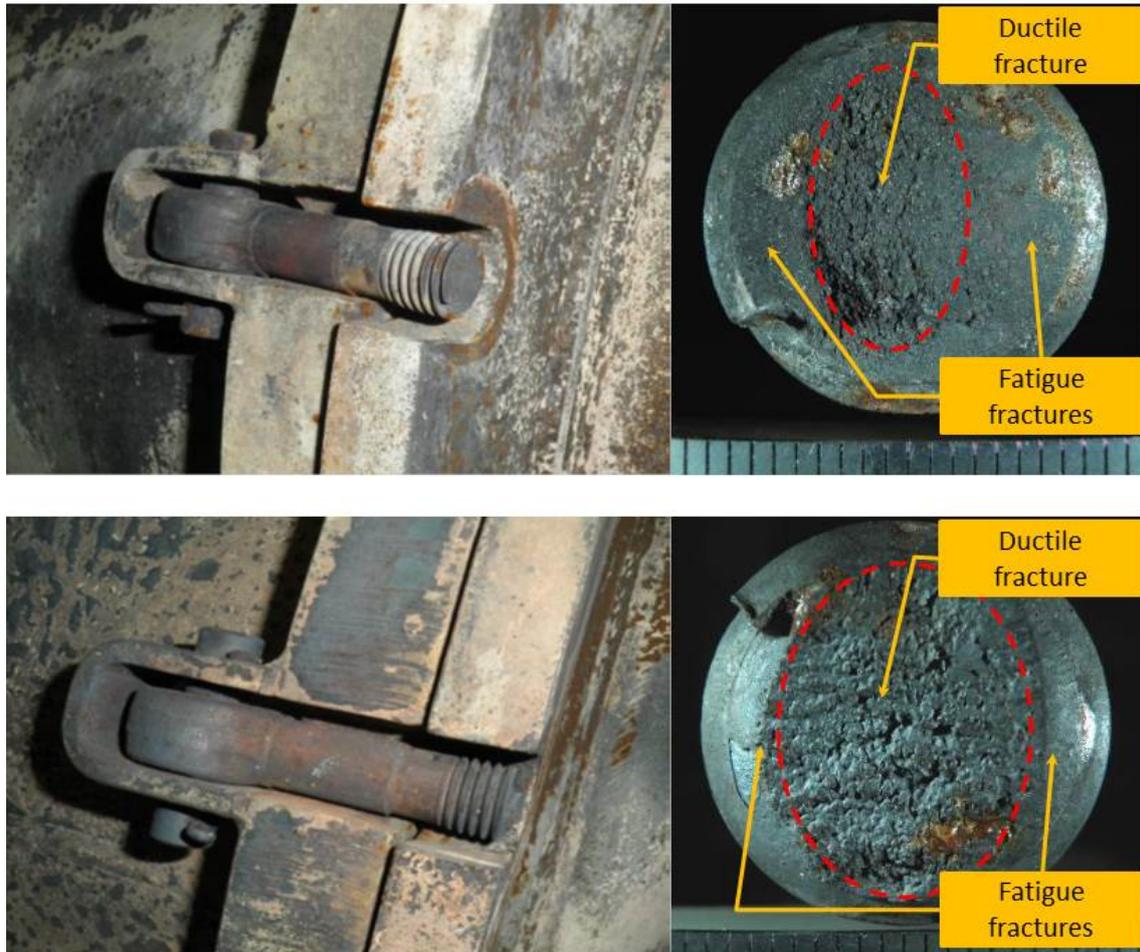
Figure 5: Bolt number 8 (Top) and 9 (Bottom) with cross sections

Bolt eight exhibited a small central region ductile fracture surrounded by fatigue fractures emanating from the root of the thread. Bolt nine had a larger ductile fracture surrounded by a smaller area of fatigue fractures. The central region ductile fractures corresponded with the final failure of the bolts (Figure 5 and 6).

The area of the ductile fracture on bolt number eight was smaller than on bolt number nine suggesting bolt eight had fatigued more and failed first. Bolt nine most likely failed after bolt eight.

- Oil filter cover retaining bolts eight and nine had failed through the first thread beneath the nut by a unidirectional fatigue failure mechanism.
- The pattern of fretting damage on the cover nut seat suggested relative movement was evident between bolts eight and nine and the oil filter cover.
